# Implementing Restoration Projects Upstream from the Teaneck Creek Conservancy

by Jeremiah D. Bergstrom<sup>1</sup>, Peter Kallin<sup>2</sup>, and Christopher Obropta<sup>3</sup>

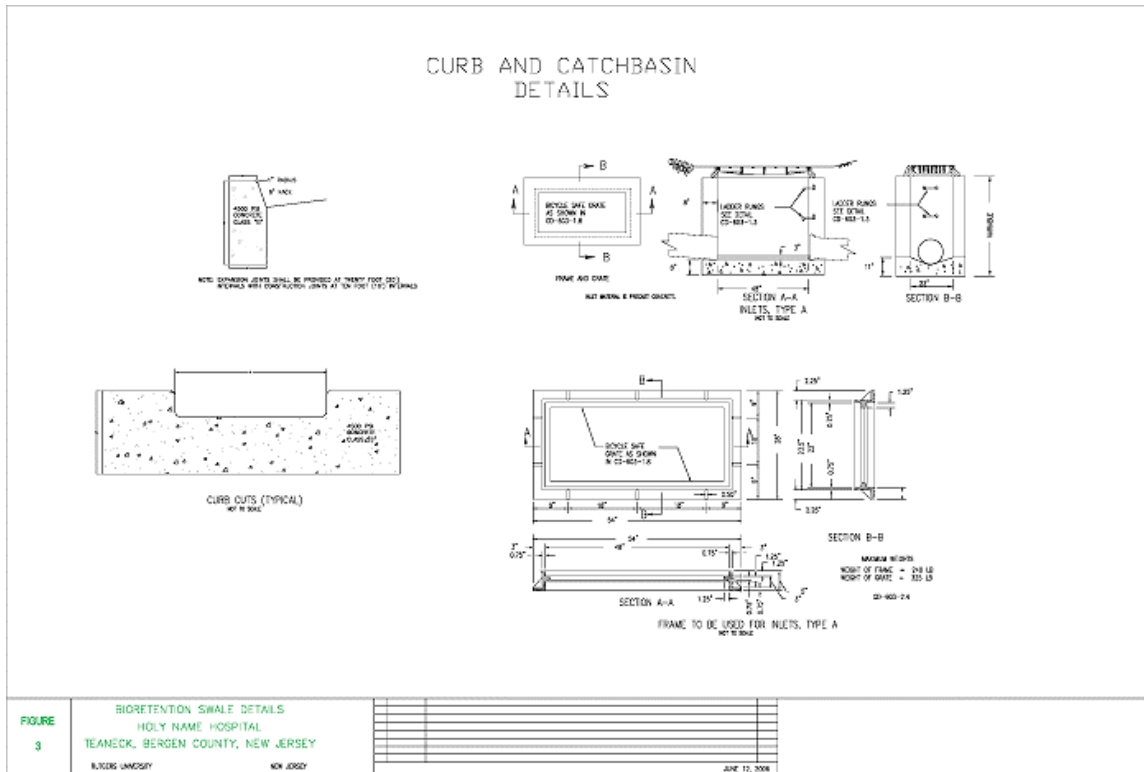
Figure 2: Conceptual details for Holy Name Hospital rain garden.

Holy Name staff contacted the Conservancy to identify steps the hospital could take to help with the wetlands restoration project. After discussions with the wetlands restoration scientists, it was determined that the most significant contribution the hospital could make would be to construct a rain garden on their property to treat runoff from the parking lot. The Rutgers Water Resources Program engineered an appropriate rain garden design to address the hospital parking area drainage patterns (Figures 2, 3).

The proposed rain garden design routes runoff from the parking lot through a set of curb cuts into a series of bioretention cells, which are incorporated into the landscaping between the hospital parking lot and Teaneck Road. The cells are designed to hold and infiltrate the NJDEP-designated, 1.25-inch Water Quality Storm. The cells are connected by grass swales that allow excess runoff from larger storms to be routed to the existing catch basin, bypassing the bioretention cells, thus minimizing erosion and damage to the rain garden system. This approach to stormwater management is designed to provide treatment for the runoff from approximately 90% of all precipitation events, significantly reducing suspended solids, oil, and grease runoff into Teaneck Creek (NJDEP 2004). The rain garden is scheduled for construction in the spring of 2008.

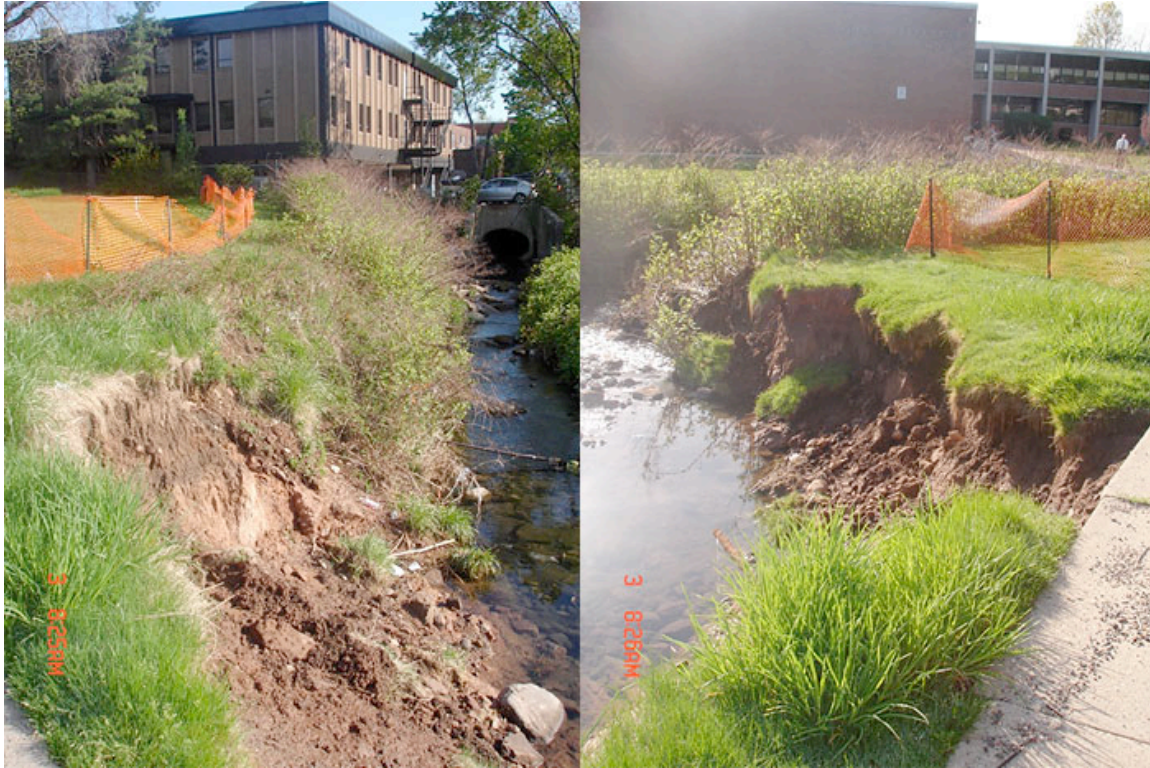
**Figure 4: Erosion downstream from discharge pipe at Thomas Jefferson Middle School.**

then discharge through a 7-1/2-by-5-foot, elliptical concrete pipe onto the property of the Thomas Jefferson Middle School. Teaneck Creek flows through the school property for approximately 900 feet before entering a culvert located underneath Fycke Lane, which discharges into the northern entrance of the Conservancy. The upstream section of the stream consists of an open channel with extensive eroding bank areas (Figure 4). High velocity discharges from the culvert outfall pipe into the stream have undermined the stream banks and caused a portion of the side bank to collapse into the streambed, causing serious safety and liability concerns. The downstream section of the stream on school property has sloping banks, which are shallow enough to minimize erosion. However, as the stream abruptly turns near Fycke Lane before discharging into the Conservancy, its slope changes and the velocity along the bank increases, causing erosion near the twin box culverts exiting the school property (Figure 5). Due to the extensive presence of the invasive Japanese knotweed (*Polygonum cuspidatum*) plant, the stream bank areas and soils have become highly erodible. During heavy rainfall events, the Japanese knotweed is continually spread downstream from the school site into the forested wetlands and stream corridors of the Conservancy.

As the site exists today, high stream flows are causing substantial stream bank erosion in the Teaneck Creek reach adjacent to the school. This erosion creates hazardous conditions on the school property in the form of steep, unstable stream banks. To remedy this problem, the Teaneck Board of Education has proposed a stabilization and restoration project, whose goals include moderating high stream flows, stabilizing the stream banks and channel, and reestablishing a native riparian buffer. Working in conjunction with the Conservancy project partners, the Teaneck Board of Education has submitted permit applications to the New Jersey Department of Environmental Protection (NJDEP). The proposed school property restoration plan addresses existing stream bank erosion and stormwater impacts, implements an invasive species management program in partnership with the U.S. Fish and Wildlife Service to control the Japanese knotweed, and commits to reestablishing a native riparian vegetative buffer along the entire length of Teaneck Creek where it flows through the Thomas Jefferson Middle School property. The Conservancy partners are working closely with the Teaneck Board of Education to provide Best Management Practices (BMPs) that will reduce ongoing maintenance and improve school safety and liability issues, while improving and enhancing this valuable ecological resource.

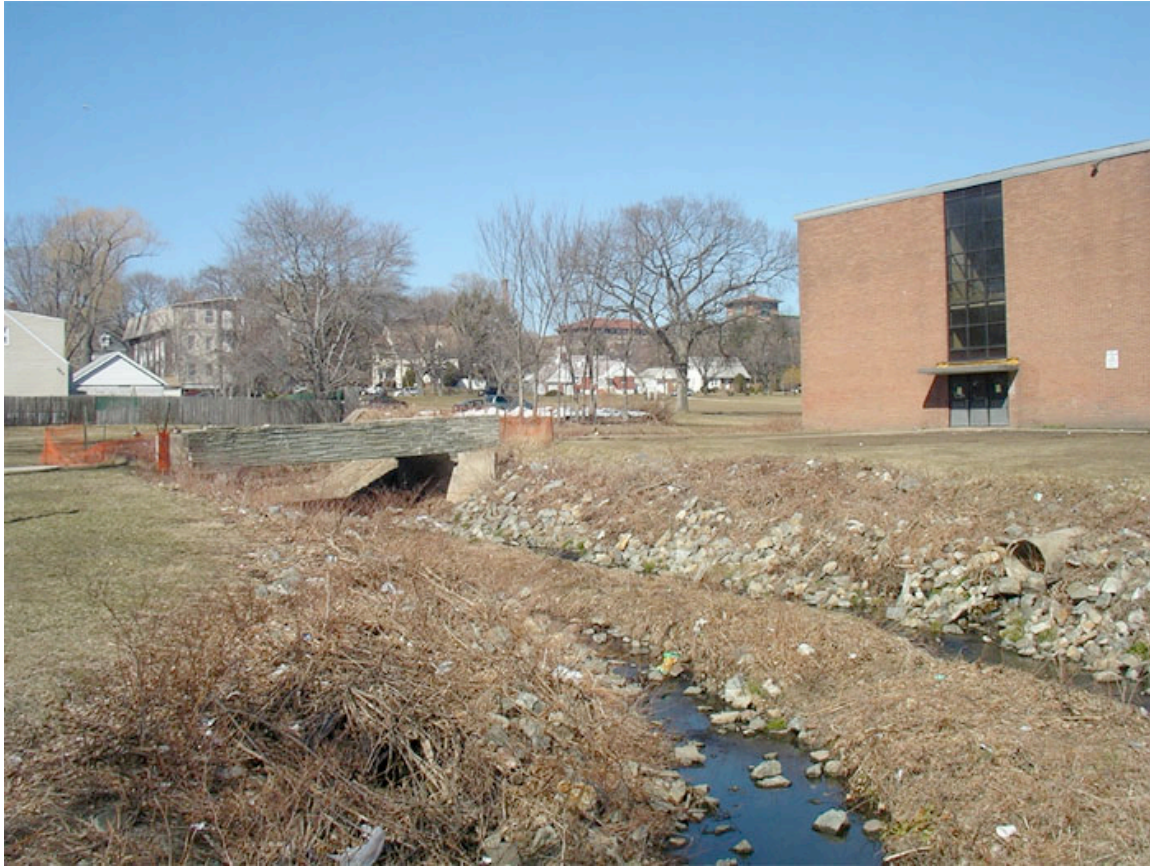
**Figure 5: Teaneck Creek near Fycke Lane at Thomas Jefferson Middle School.**

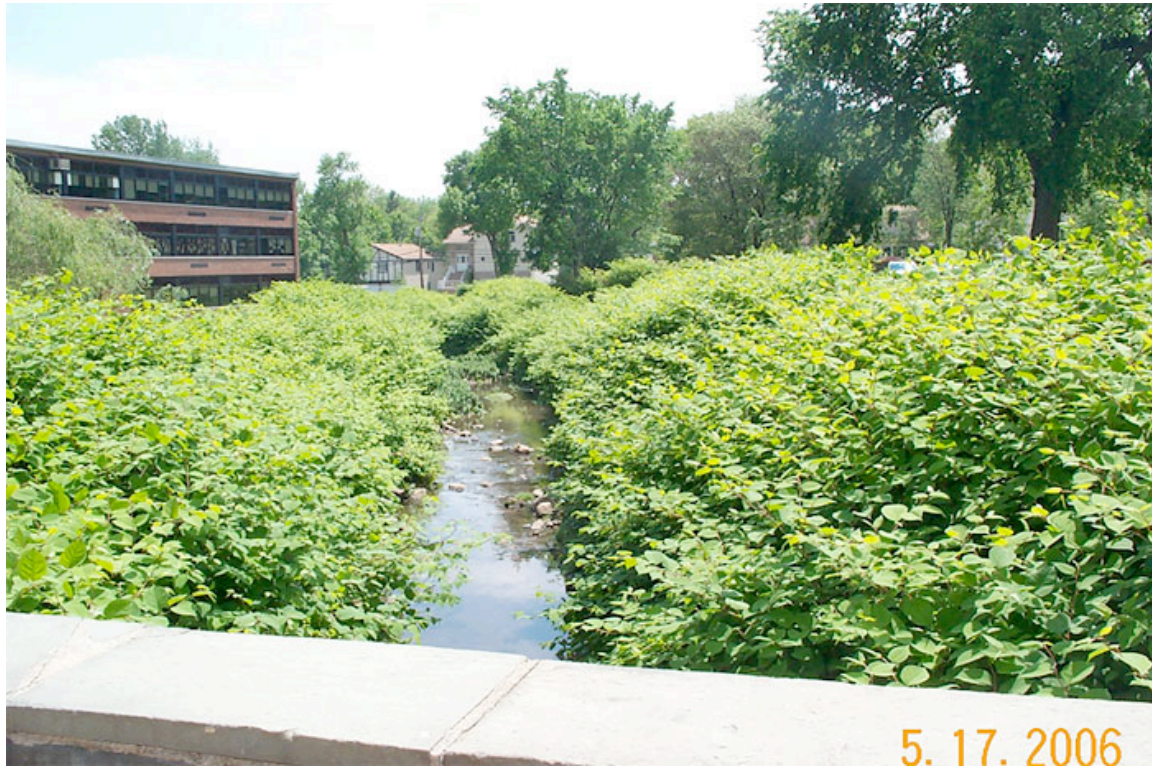
**Figure 6: Japanese knotweed (*Polygonum cuspidatum*) colonization along Teaneck Creek on Thomas Jefferson Middle School property.**

One of the most significant off-site influences on this site is extensive invasive species colonization, dominated by Japanese knotweed, along Teaneck Creek at the Thomas Jefferson Middle School property immediately upstream from the restoration site (Figure 6). This upstream source of seed and

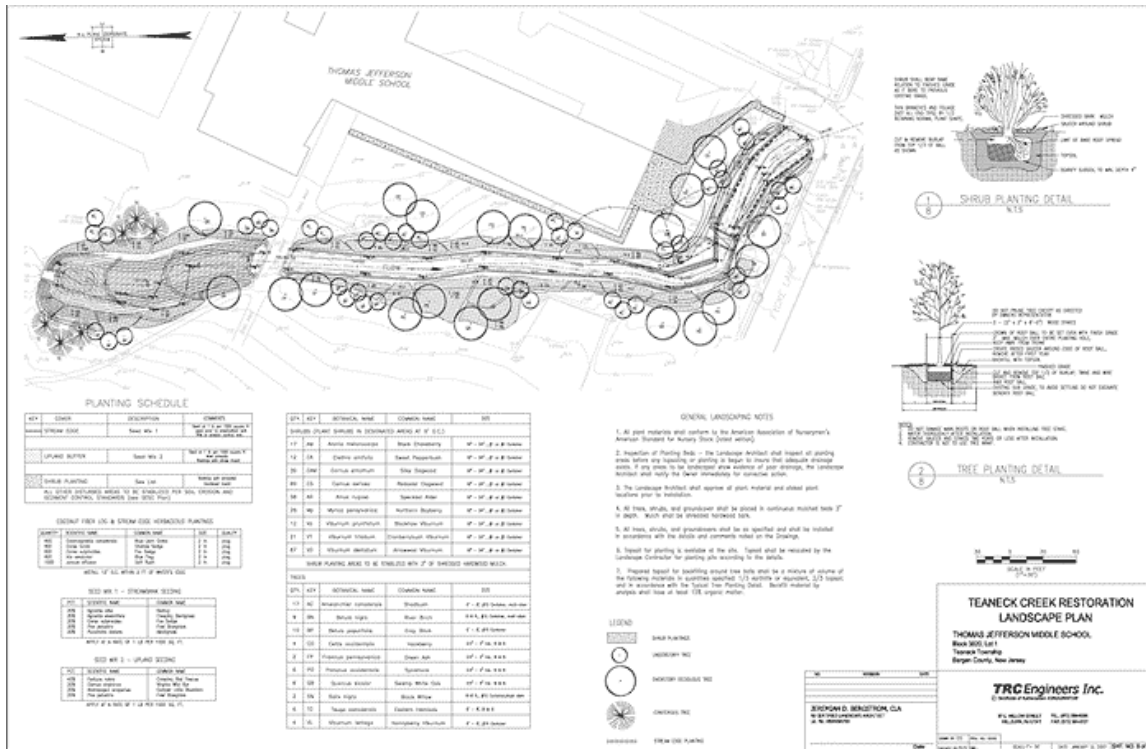
Figure 8: Landscape plan for Thomas Jefferson Middle School.

The second phase of the project is restoration and stabilization of stream banks along an additional 600 linear feet of stream (Figure 8). Work in this section will include removal of a pedestrian bridge crossing the stream, regrading of stream banks to a 3:1 slope, and construction of a 4-foot-wide safety shelf. The regrading activities will remove the invasive Japanese knotweed and establish native riparian vegetation. Plantings and stabilization efforts will be enhanced with the installation of coconut fiber logs and boulders and the use of erosion-control mat or turf-reinforced mat.
